# Gantrex Port Crane Services – IMPROVING STS DRIVER COMFORT

# Diagnosing the Problem – Visual Inspection

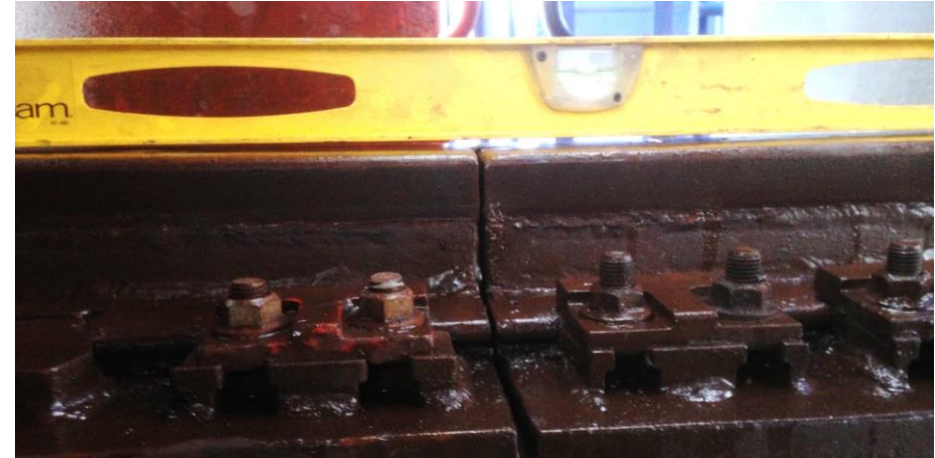
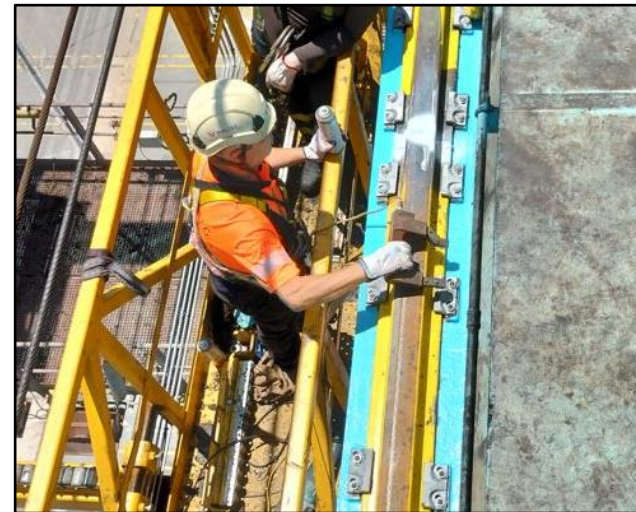
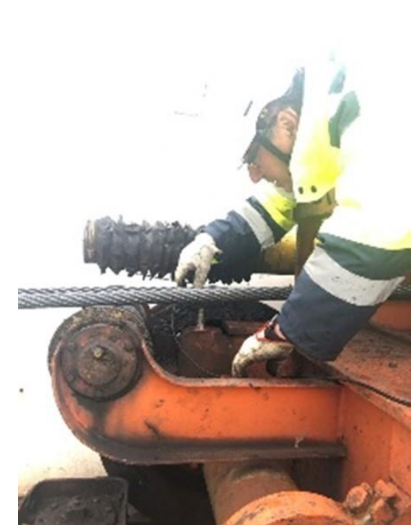
- Visual inspection was performed on the full **trolley rail** and trolley rail **structure**
- Observed **degradation** of the **hinge joint** area with large **localized wear** at the joint
  - Such wear is **typical** with **hard mounted system**
  - Wear is usually **concentrated on the finger** due to the **discontinuity** at the hinge joint and **load transition** from one rail to the next
- Observed **localized wear** on the **welds** of the trolley rail
  - This is **typical** as the **material** at the weld joints is normally slightly **softer** than the head of the rail and wears quicker

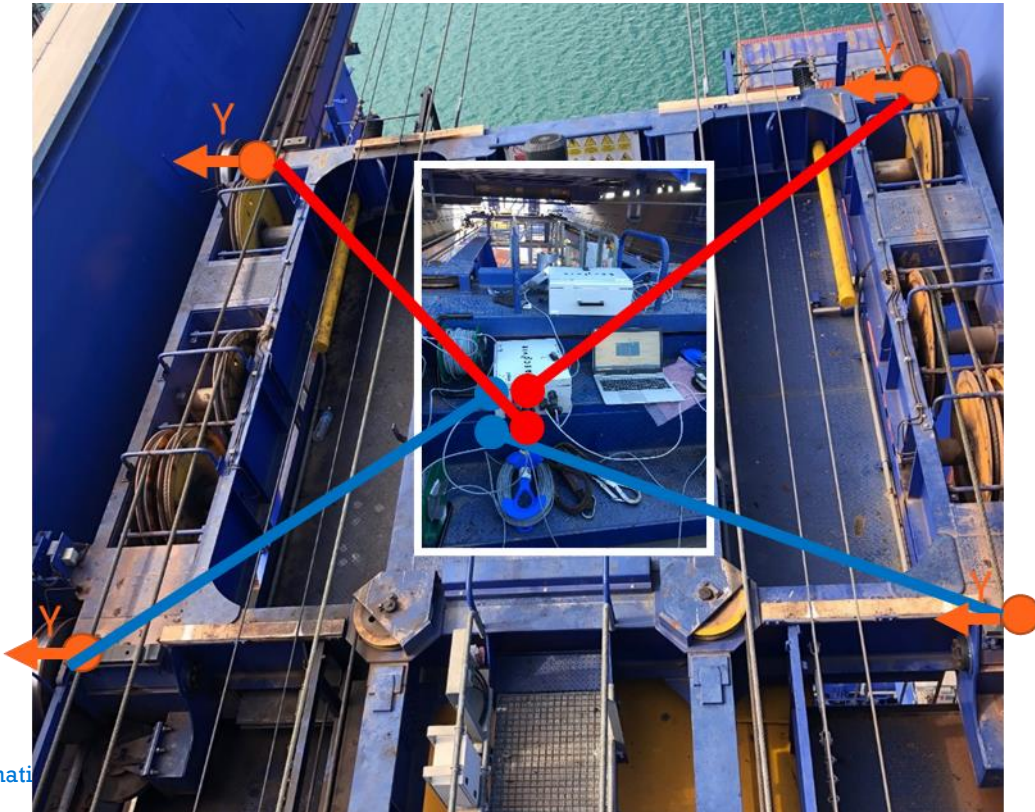
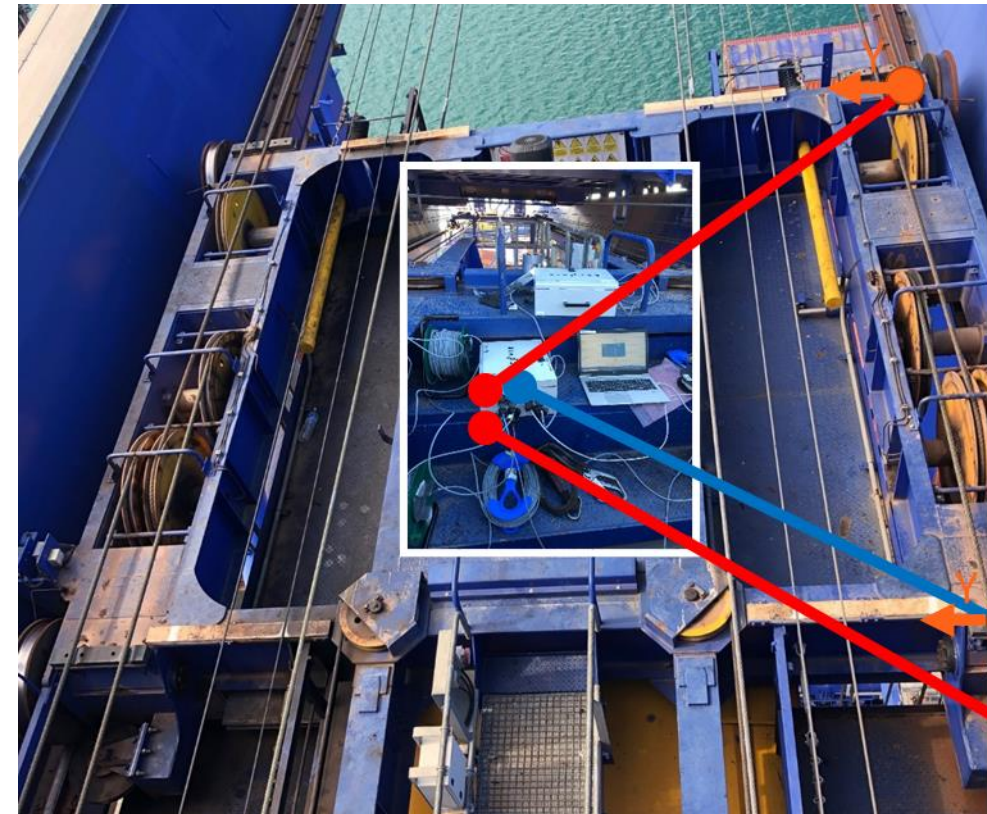
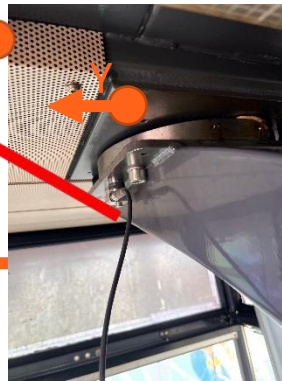
- GMP needed to **quantify** the **vibration** and understand where it is coming from
- **Vibration Analysis** was carried out by installing sensors on each corner of the **trolley**, **driver cabin**, and driver seat

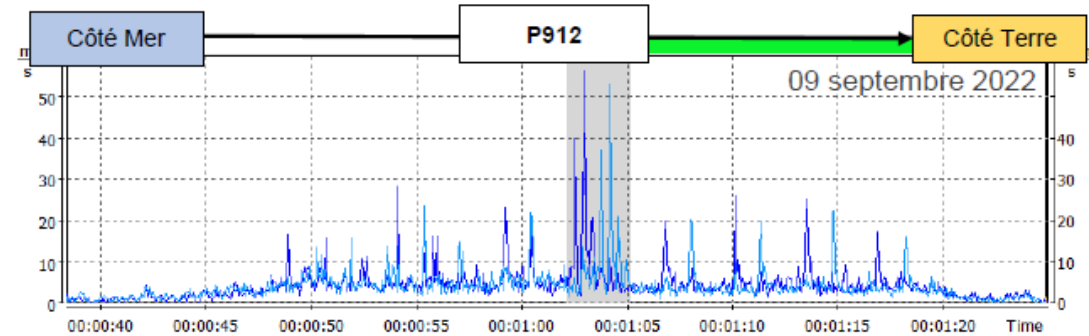
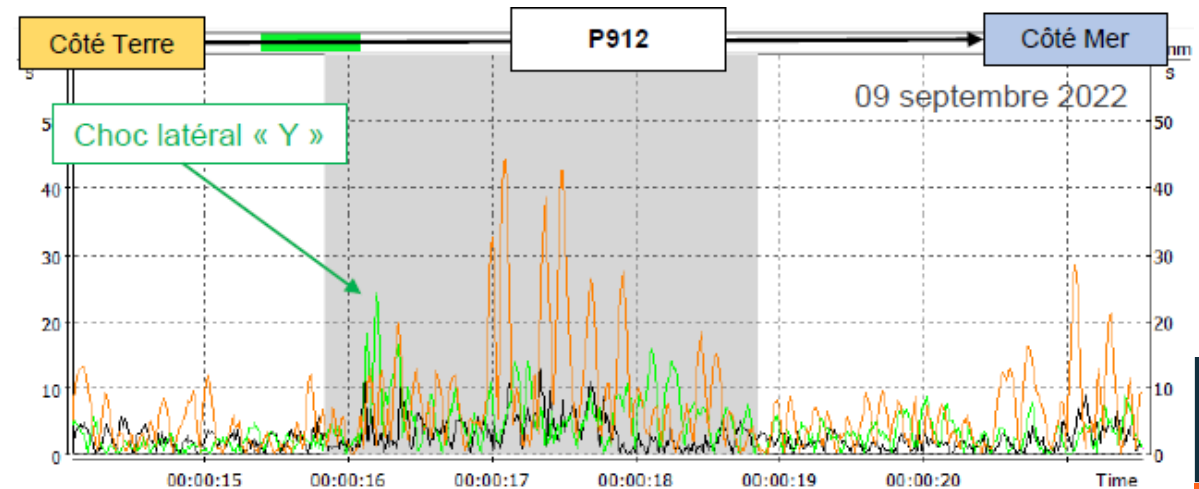
- Large shocks and vibrations were observed especially when the trolley passed over the Hinge Joint
- Some shock and vibration observed over the welded joints on the long rail
- Lateral vibrations at the driver seat were excessive
- Visual inspection confirmed wear at the weld joints and a degraded hinge joint

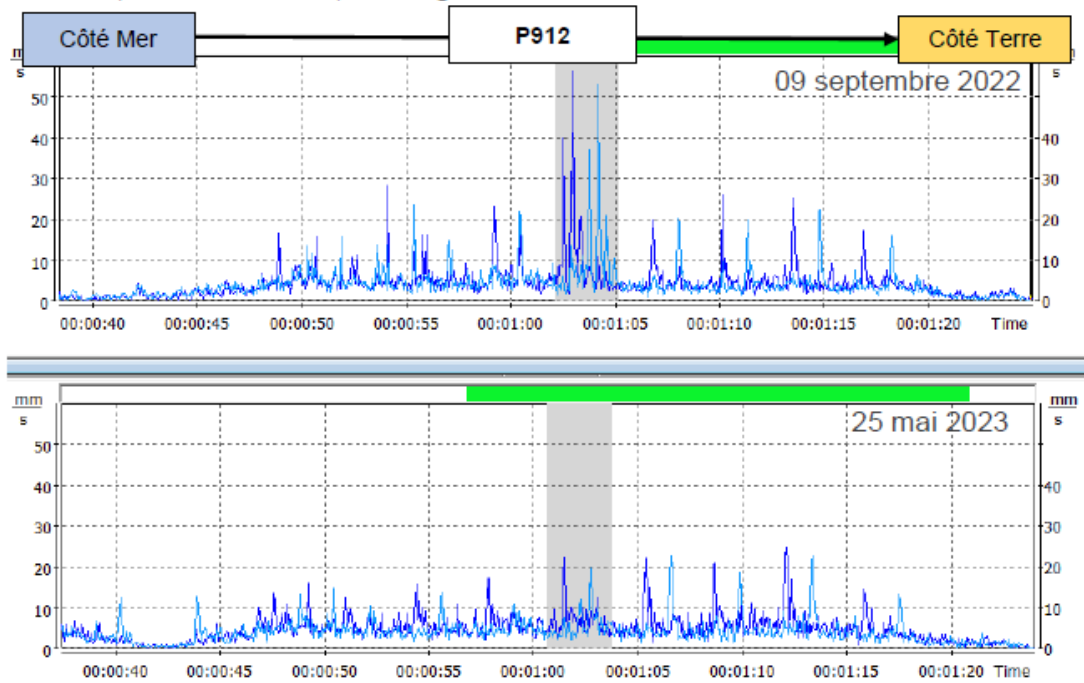
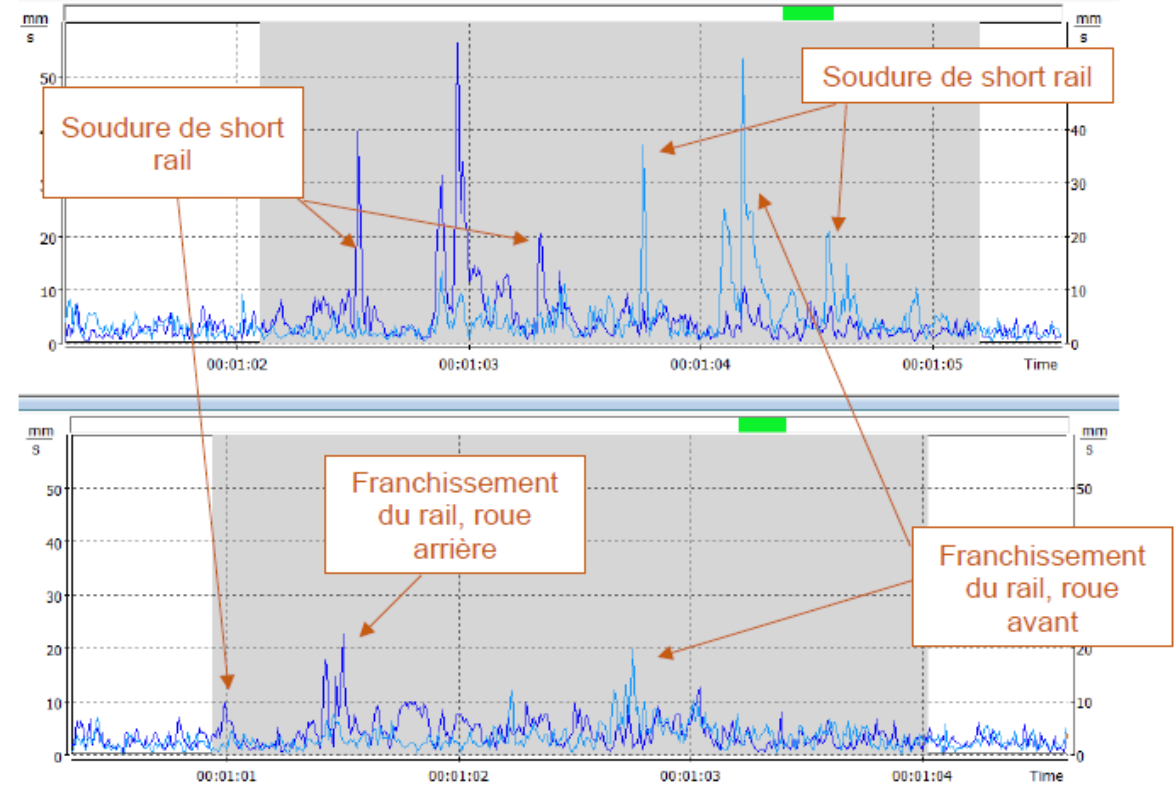
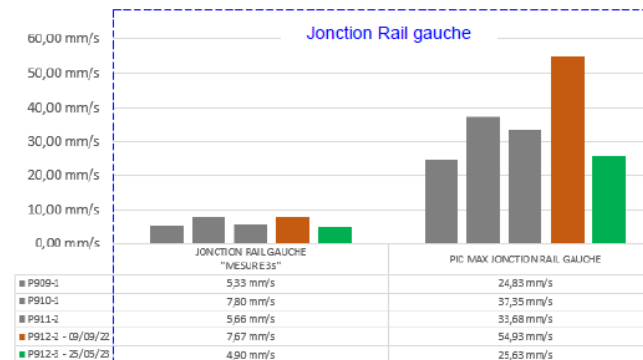
- Vibrations -36% & 2x shocks

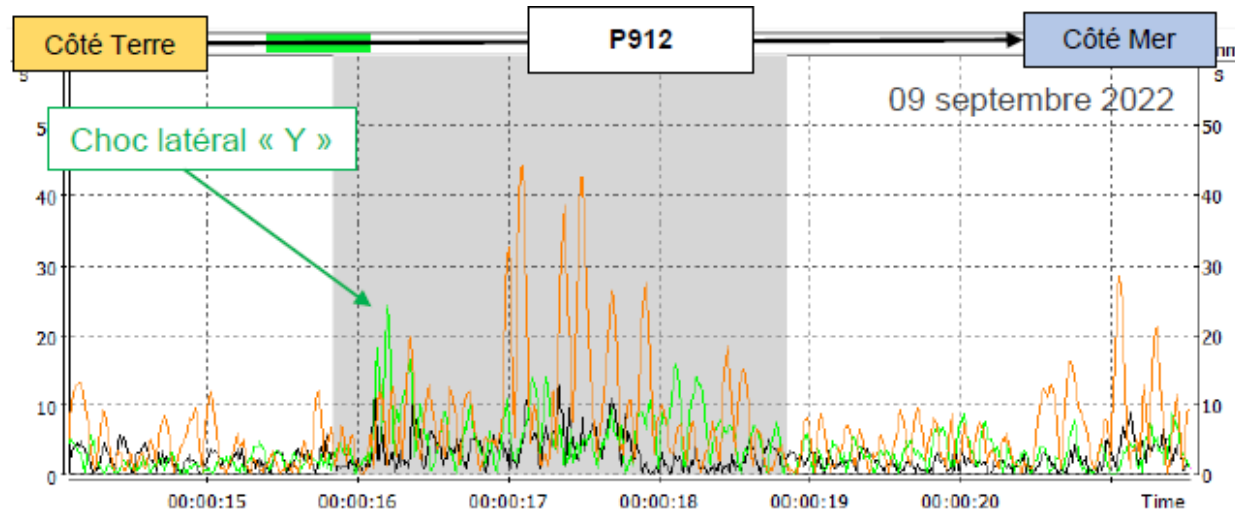
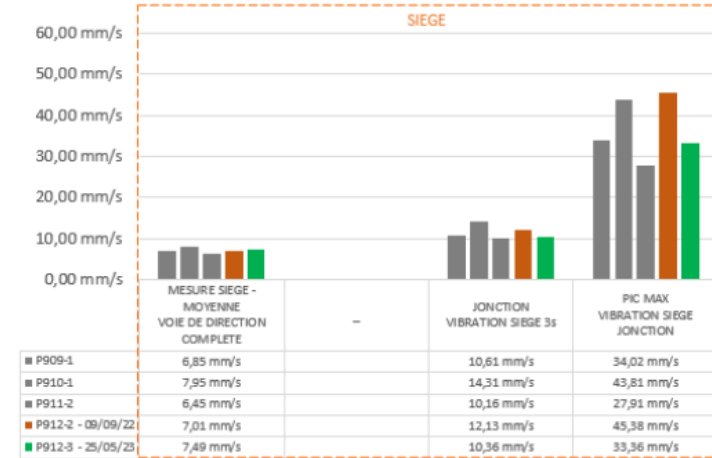
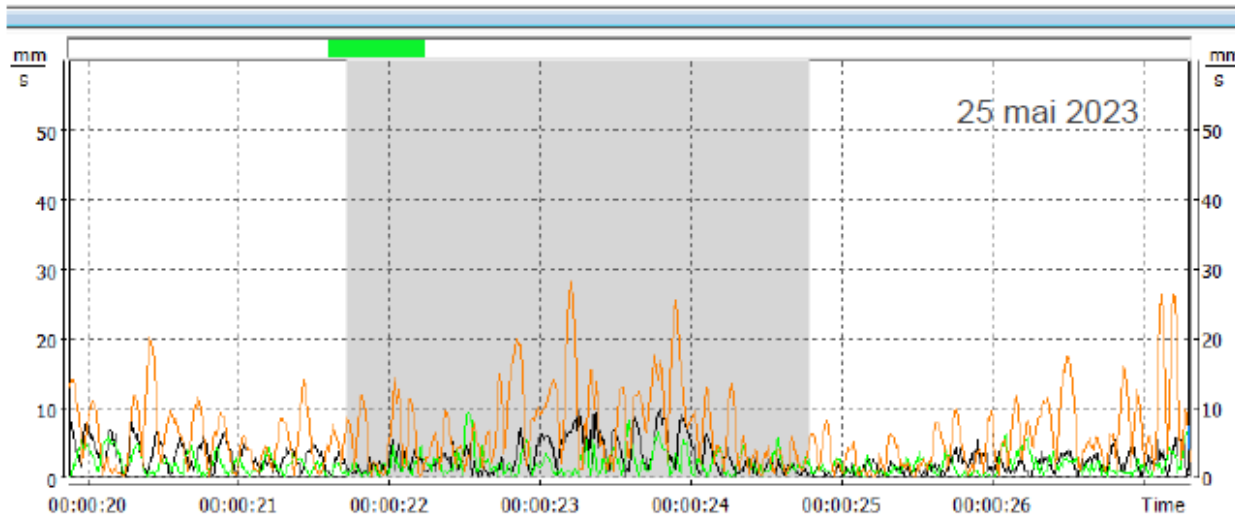
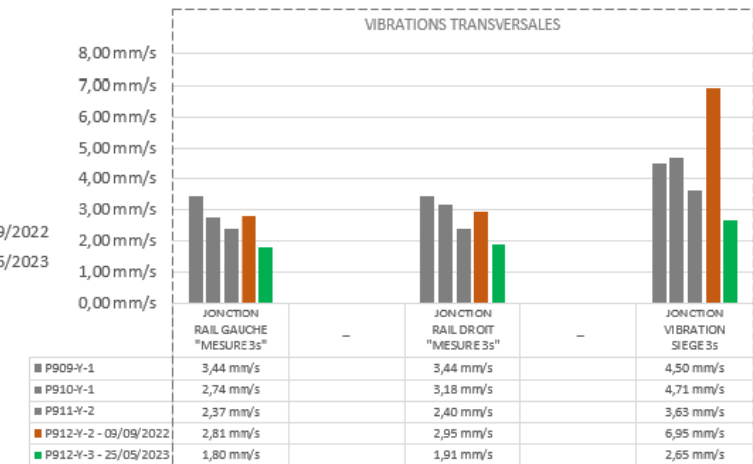
Driver seat : RMS reduced by 62% in lateral direction

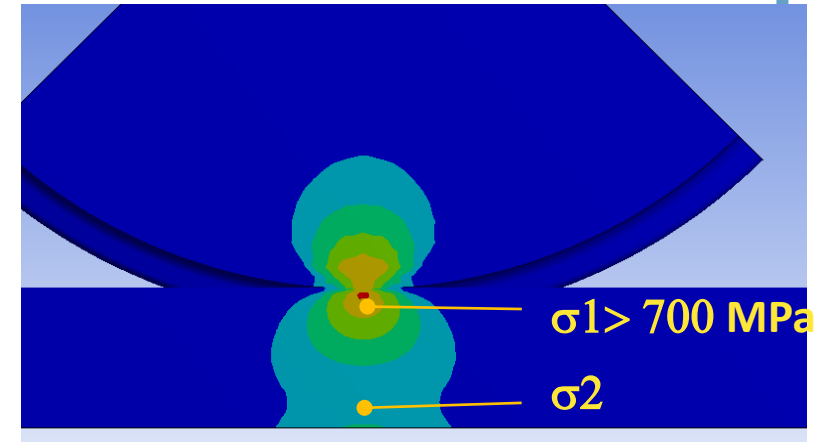
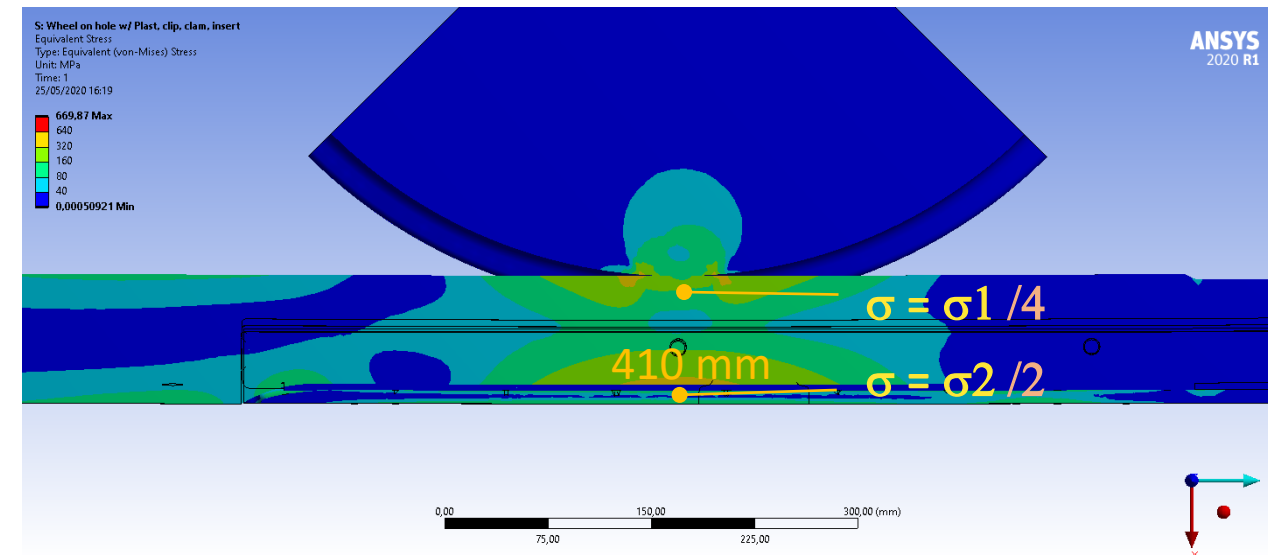
- Follow up **vibration analysis** was carried out in **March 2024** – almost 1yr after the replacement
- **No increase in vibration** from the time of replacement
- The **rubber layer** within the HGSR **protects the top of the rail** from localized wear at the joint
- This has been **modeled with FEA** and is now **observed on site**
